MAY 02 2012 U.S. DEPT. OF THE INTERIOR
OFFICE OF SURFACE MINING
DIV OF OIL, GAS, & MINING Mine Site Evaluation
State Program

Mine Site Inspection

Mine Name: Coal Hollow Mine

Inspection Date: April 4, 2012 10:00 – 3:00

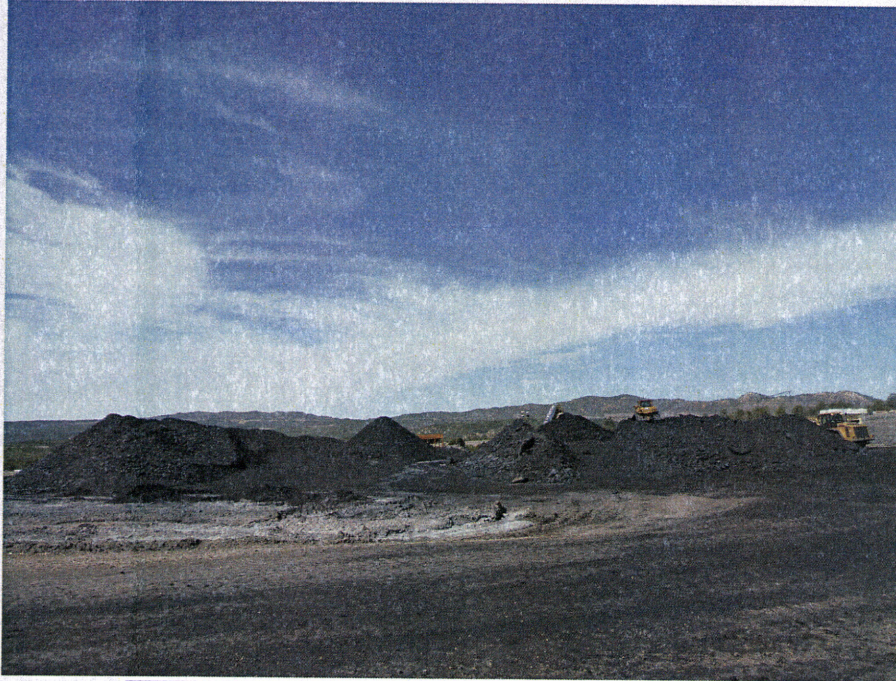
Photo ID: 6806

Ongoing Activities: Alton Coal Development (ACD) is currently mining Pit 5. The upper portion (approximately 2') of the coal seam is higher in sulphur, so ACD stockpiles that coal separately. Coal is transported away from the mine site via truck. ACD is constructing the excess spoil fill within the footprint permitted for this activity.

Subject: COAL STOCKPILES, HIGH SULPHUR MATERIAL ON LEFT

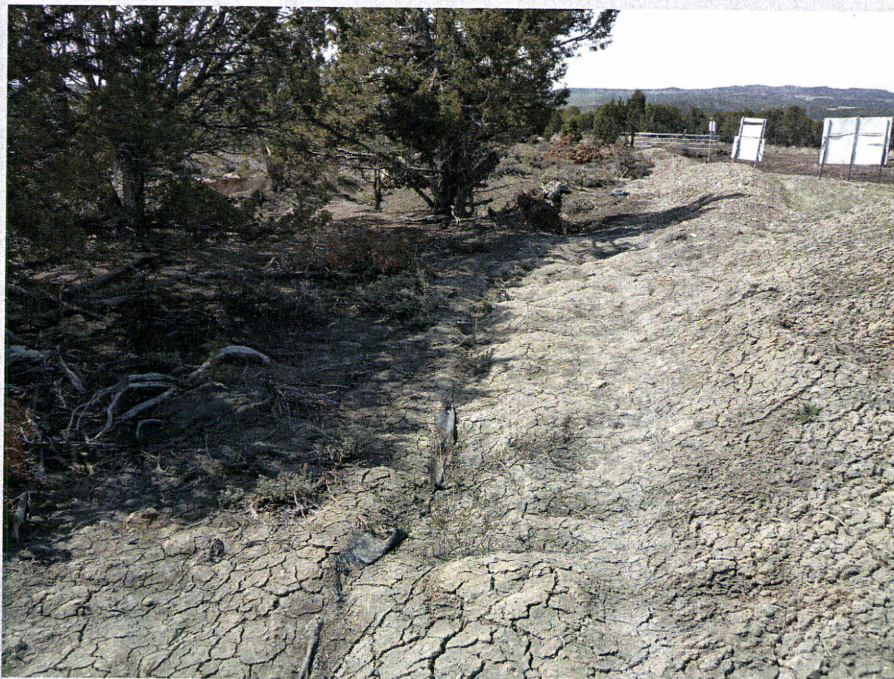
Photo ID: 6807

Pond 1B was holding water but not discharging at the time of inspection. ACD removed a section of silt fence south of the pond (see photo 6807). Sediment control is still necessary in the area. Please install sediment control of some type (silt fence, straw wattles, vegetation, etc.). The discharge culvert is UPDES outfall 001B.

Southwest of Pond 1B

Subject: SILT FENCE REMOVED, SEDIMENT CONTROL NEEDED

- A section of silt fence south of Pond 1B is missing. Sediment control is still necessary in the area. Please install sediment control of some type (silt fence, straw wattles, vegetation, etc.).

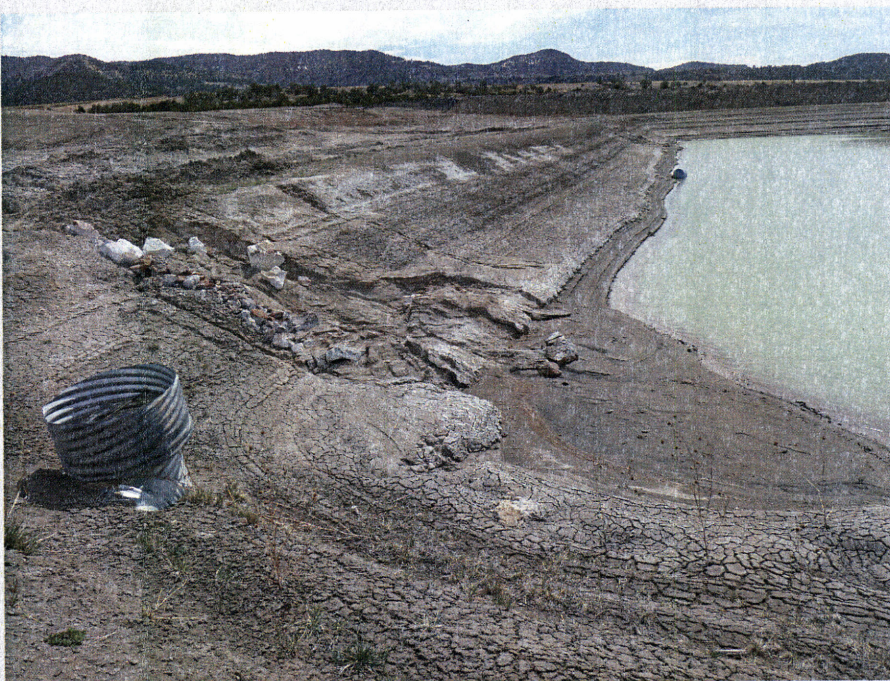
Photo ID: 6808

Pond 2 was holding a small amount of water but not discharging at the time of inspection. A water pump was on site to collect water for dust suppression, but it was not running. The pond has two inlets, one of which is located immediately adjacent to the pond discharge structure (see photos 6808 and 6809). This type of pond design does not allow adequate residence time for suspended solids to settle, commonly referred to as "short circuiting the pond." This is especially problematic due to the high clay content in area spoils (suspended clays require a longer residence time to settle). The drainage basin

appears to be a relatively small area, easily lending itself to several potential solutions. ACD could attempt to connect this channel to the eastern inlet diversion in Pond 2, connect it to the Pond 3 inlet diversion, or even apply to DOGM for a small area exemption under R645-301-742.240 (this statement does not guarantee approval). The Pond outlet structure is UPDES outfall 002.

Subject: POND 2 INLET ADJACENT TO OUTLET STRUCTURE

- Pond 2 is short circuited. Please explore your options for redesigning the western inlet to allow adequate residence time.

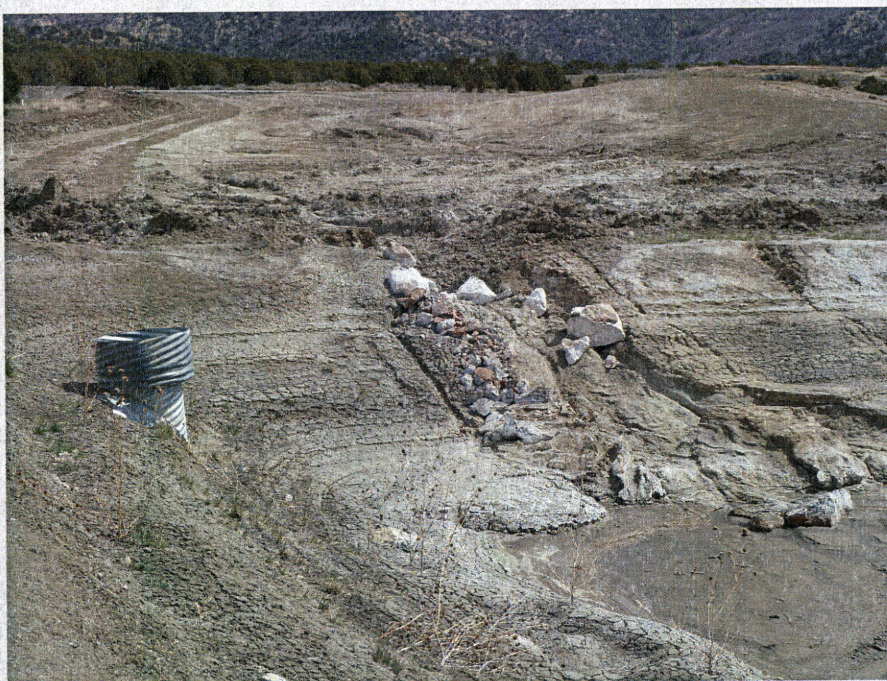
Photo ID: 6809

Pond 2 inlet diversion adjacent to outlet riser culvert.

Subject: SHORT CIRCUITED POND

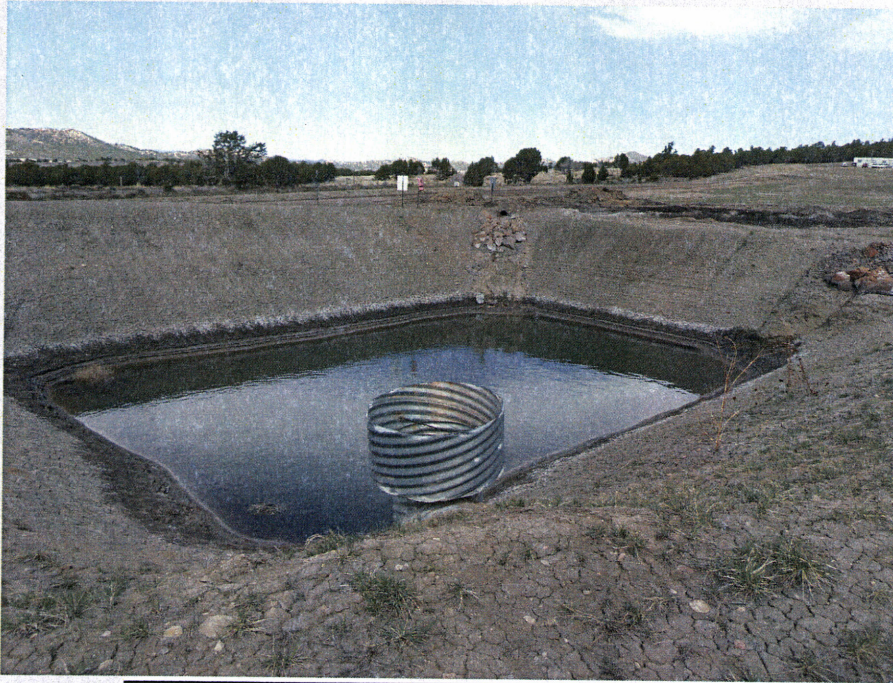
Photo ID: 6810

ACD employs combination primary and emergency spillway discharge structures. The structures on Ponds 1, 1B, and 2 are oversized riser culverts. Pond 3 has an open channel spillway. DOGM may have erred in approving the closed-channel combination principal and emergency spillways at Coal Hollow. Combination spillways are meant to be open channel (R645-301-742.223). Open channel spillways allow water in excess of the design event (25-year / 6-hour storm event) to discharge without compromising the integrity of the impoundment.

As noted, combo principal & emergency spillways are generally open-channel. DOGM may have erred in approving Pond 1, 1B, and 2 spillway designs.

Subject: POND 1B ONLY SPILLWAY IS CLOSED-CHANNEL

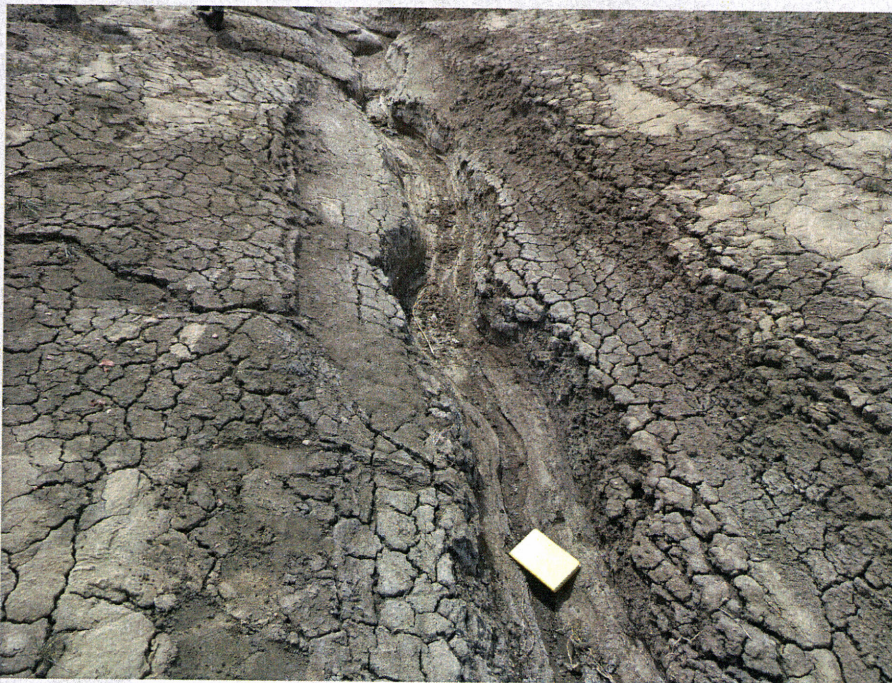
Photo ID: 6811

ACD rerouted a portion of the Lower Robinson Creek. This Lower Robinson Diversion is eroding. ACD already submitted a permit revision to rip rap the northeastern portion of the channel. The southwestern portion of the channel is also down-cutting and would benefit from rip rap (see photo 6811). Pond 5 used to be at the northeastern-most (upstream) location along this diversion. ACD removed this pond, and disturbed area runoff is no longer routed through the diversion. UPDES outfall location 005 was at the Pond 5 outfall. Because no disturbed area runoff reports to this diversion, it is not necessary to monitor flows under UPDES.

ACD has submitted a permit revision to rip rap the northeastern portion of this channel. The southwestern portion requires stabilization as well.

Subject: LOWER ROBINSON CREEK DIVERSION ERODING

- The flat area east of the haul road near Pond 1 requires berms / diversions to ensure drainage is routed to Pond 2.
- ACD already submitted a permit revision to rip rap the northeastern portion of the Lower Robinson Diversion channel. The southwestern portion of the channel is also down-cutting and would benefit from rip rap.
